Northern Technologies

Product Enhancement Announcement

June 28, 2018

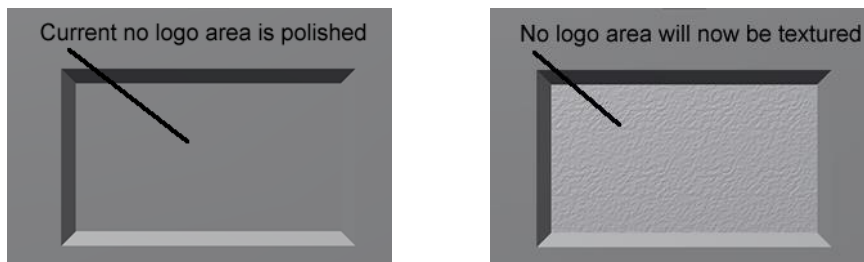
CHANGE WILL BE AS FOLLOWS:

The no logo insert area of our standard plastic CPP gray, plastic CPP black and metalized plastic CMP series connector covers will be changing from a polished area to a textured area.

Renderings shown are for illustrative purposes only.

This will help hide any imperfections due to packaging of plastic or during the rinse spin cycle of metalized plastic connector covers.

This will not affect the form, fit or function of the part and is strictly to reduce the number of visual scratches in the connector cover blank logo area.
